Test Report

Sample Name : LED Recessed spot Light

Sample Model : IS0002-LED07-3090-36D

Test item : Dust test
Test standard : IEC 60068-2-68: 1994
Test result : PASS

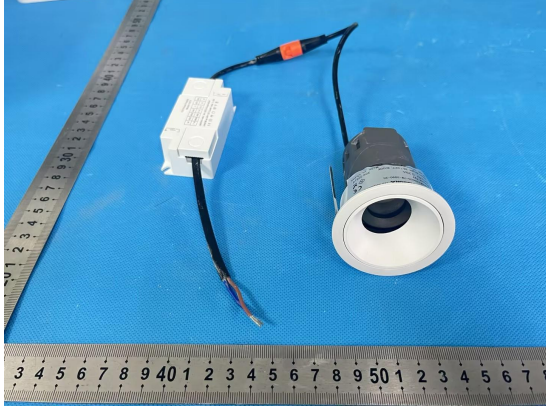
Sample Photo before the Test:

Appearance inspection

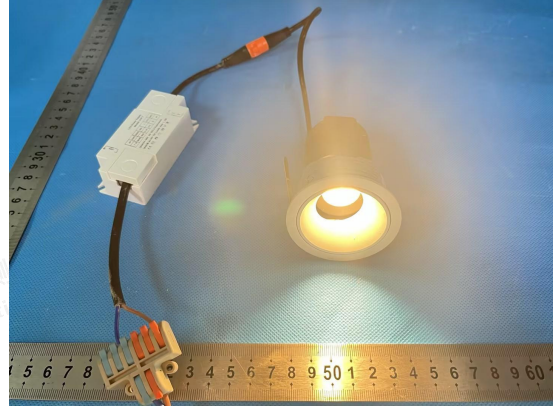
Function inspection

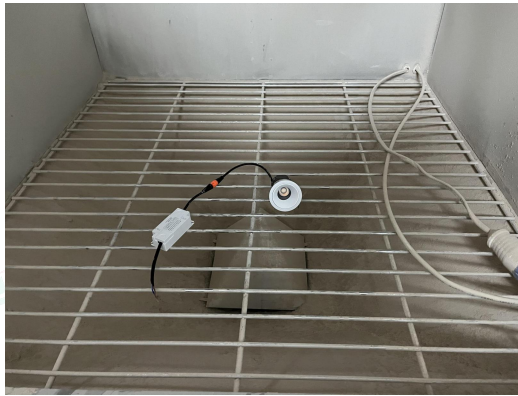
Sample Photo during the Test:

- Expose samples to high concentrations of dust-containing air streams containing high concentrations of non-corrosive fine dust of less than 75µm size;
- Test time: 8H;
- Sample test condition: Non-Package/Non-Operation;
- Test chamber temperature and humidity: 40°C, <25%RH;
- Judgment requirement: After the test, no dust enter into the sample, the sample function is normal.

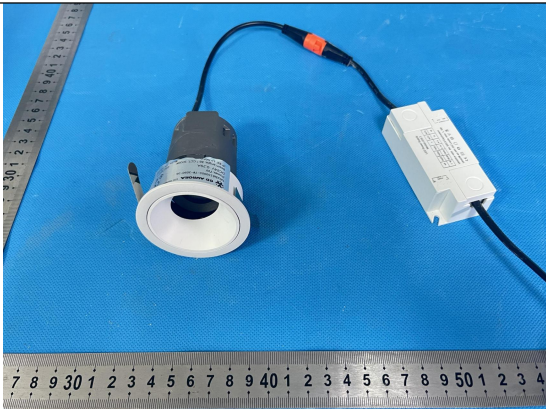
Sample Photo after the Test:

Appearance inspection

Sample No.	Test result	Judgment
C060223003-001	After the test, no dust enter into the sample, the sample function is normal.	PASS

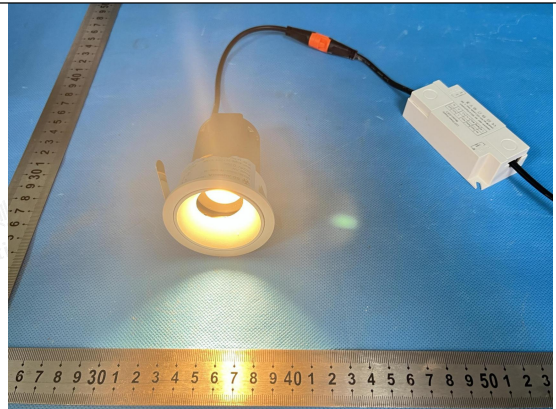
Function inspection

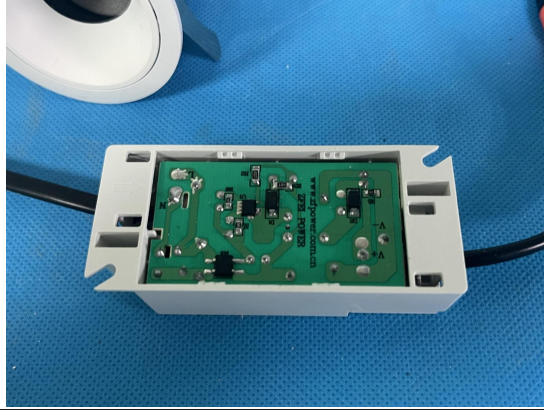
Sample Photo after the Test:
